Original HP Inkjet Print Cartridges vs. Third-Party Refilled Cartridges

EXECUTIVE SUMMARY

In February 2011, Buyers Laboratory Inc. (BLI) completed a study for HP designed to test the page yield and reliability performance of Original Hewlett-Packard (HP) #56 Black, #57 Color, #60XL Black, #60XL Color, #74XL Black and #75XL Color inkjet print cartridges compared to a sampling of cartridges from leading refill service providers. All cartridges tested were sold in North America.

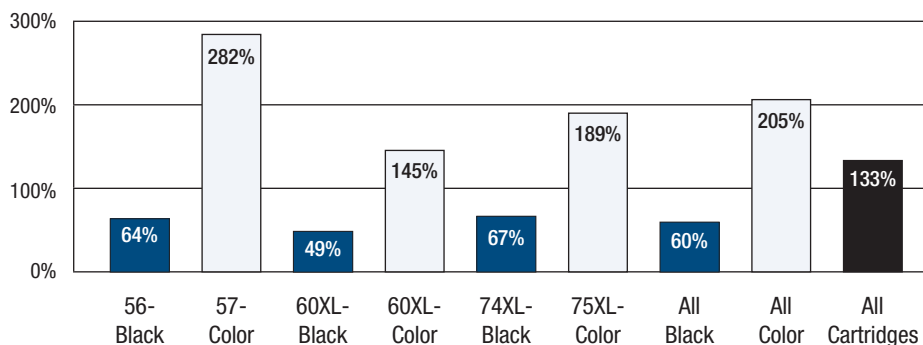
Graph I: Percentage More Pages Printed by HP than by Re-fillers per SKU, per Color and per All Cartridges

Throughout testing, each of the Original HP inkjet print cartridge types produced average page yields that were superior to those of the refilled cartridges and, as illustrated in Graph I below, outperformed the refilled cartridges by printing the following percentages of additional pages:

- Original HP #56 Black cartridges: 64% more pages printed
- Original HP #57 Color cartridges: 282% more pages printed
- Original HP #60XL Black cartridges: 49% more pages printed
- Original HP #60XL Color cartridges: 145% more pages printed
- Original HP #74XL Black cartridges: 67% more pages printed
- Original HP #75XL Color cartridges: 189% more pages printed

When looking at the average page yields for the black and color cartridges separately, Original HP black inkjet print cartridges produced 60% more pages on average than the refilled cartridges, while Original HP color inkjet print cartridges produced 205% more pages on average than the refilled cartridges tested.

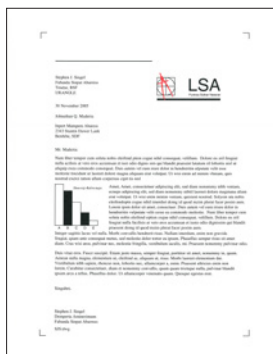
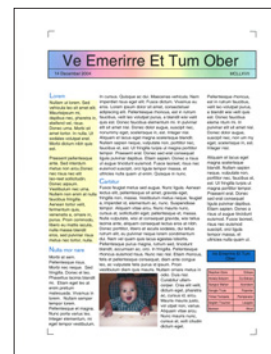
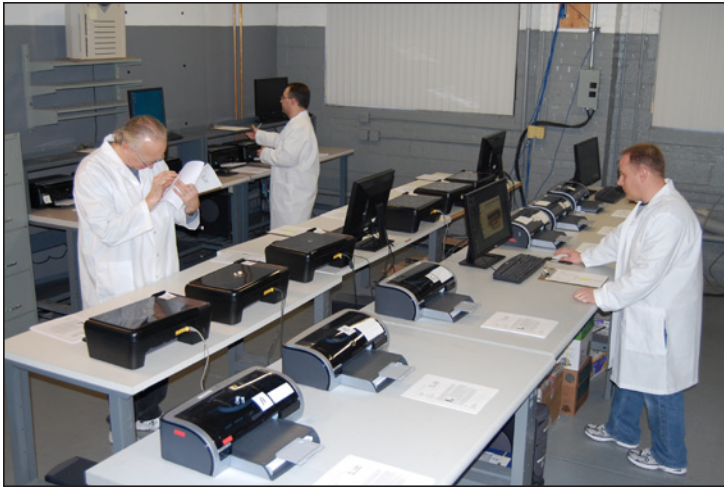
The ISO/IEC 24712 Test Suite

Printing was performed in a continuous mode in a controlled environment using the ISO/IEC 24712 five-page color test suite, and the environmental conditions specified in ISO/IEC 24711. To account for reliability-driven cartridge issues, defective cartridges were included in the page yield calculations. Consequently, the reported page yield numbers are not based on the ISO/IEC 24711 standard, as ISO/IEC 24711 requires that defective cartridges are excluded from the page yield calculation. This was done to account for the negative user experience with defective or failed cartridges.

Test Page Suite	<p>A series of five pages that are printed consecutively in order as a single job, ending with a diagnostic page, ISO/IEC 24712. See sample on page 5.</p>

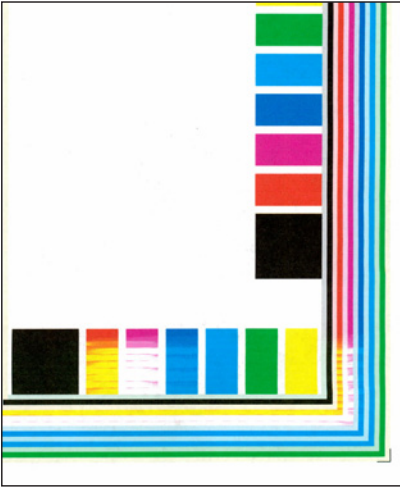
<p>Color Fade</p> </div> <div style="text-align: center;">

Fade	<p>A significant decrease in density on the bands or blocks of the last page in the test page suite, which is a diagnostic page. This decrease in density does not have to occur completely across the page to be considered fade. For a comparison to determine if fade is occurring, reference the 10th page printed by that printer.</p> <div style="display: flex; justify-content: space-around; align-items: center;"> <div style="text-align: center;">

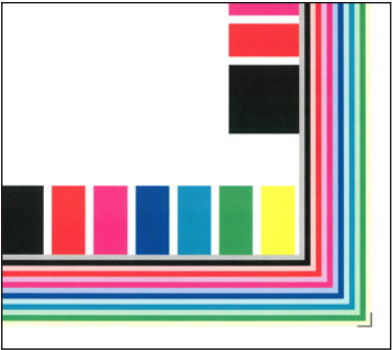
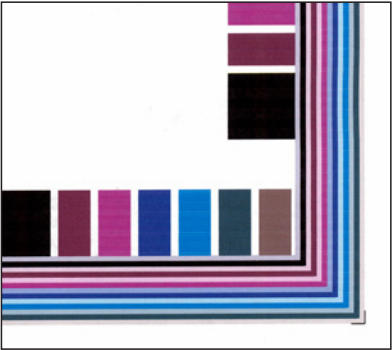
<p>Color Mix</p>	<p>Defined as a color cartridge that cannot print the correct Cyan, Magenta and Yellow colors as shown on the diagnostic page 5 of the page yield test suite. Ink has mixed in an unintended manner inside the cartridge and has caused a dis-coloring of the ink.</p> <p>An example of Color Mix is provided at right. Compare the colored blocks in the correct example to those of the color mix page.</p> <div style="display: flex; justify-content: space-around; align-items: center;">

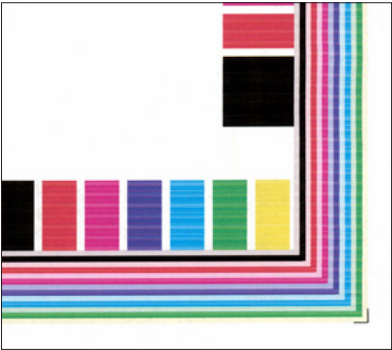
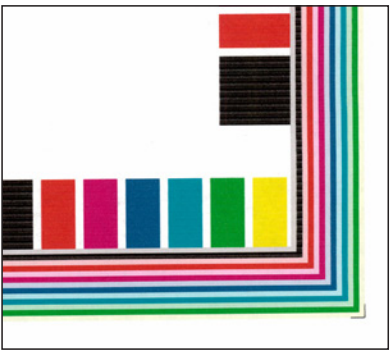
</div> <div style="display: flex; justify-content: space-around; align-items: center;"> <p>Color Streaking</p> <p>Black Streaking</p> </div>

</div> <div style="display: flex; justify-content: space-around; align-items: center;"> <p>Correct Diagnostic Page</p> <p>Color Mix</p> </div>
<p>Streaks</p>	<p>Very thin lines of color or the lack of color where it should be, in the blocks surrounding the edge of the diagnostic page. Streaks differ from fade in the width and severity of the reduction in density. Streaks can appear due to a number of reasons, including thermal issues and clogged nozzles.</p> <div style="display: flex; justify-content: space-around; align-items: center;">

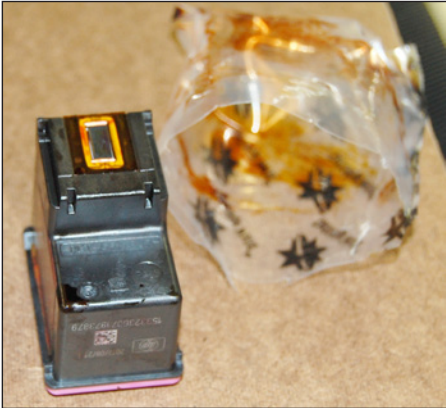
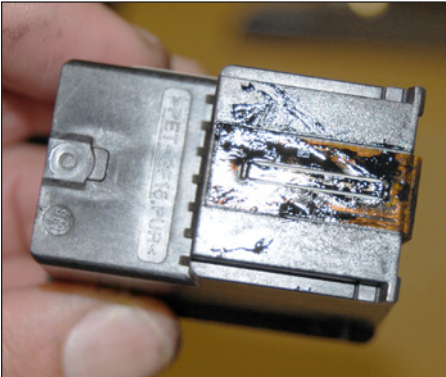
Substantial Ink Leakage	<p>Significant amount of ink visibly spilled in the plastic bag containing the cartridge.</p>

<p>Significant amount of ink visibly spilled in the interior of the cartridge packaging.</p>
	<p>Significant amount of ink visibly spilled over the print head nozzles.</p>

Each cartridge was inspected for leaks or other damage upon entering the test and a cartridge with substantial visible ink spilled in the bag or on the cartridge was declared DOA. All other cartridges were printed to EOL as defined in Appendix II: Definitions.
